Date din studiul geotehnic realizat de S.C. TERRASOIL TEHNICA S.R.L., 2024

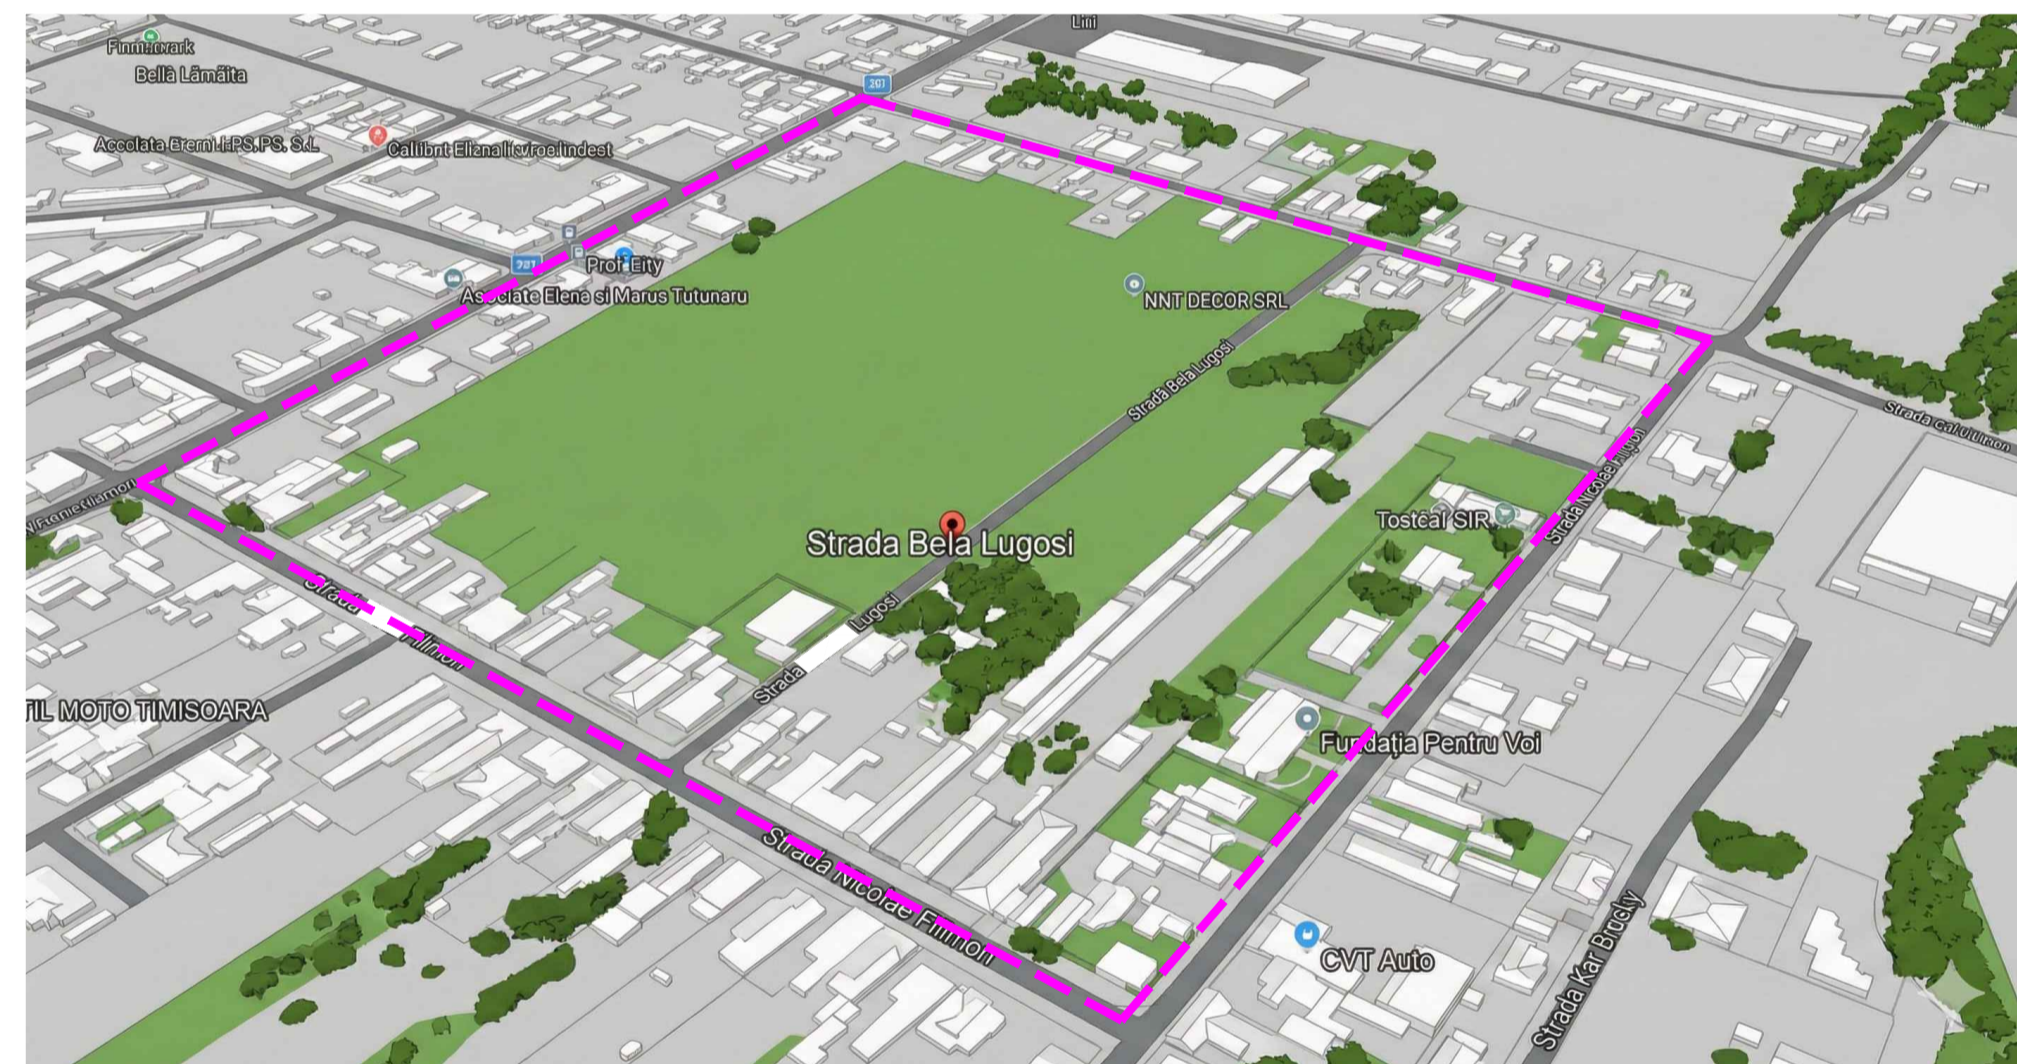
Regimul de inaltime

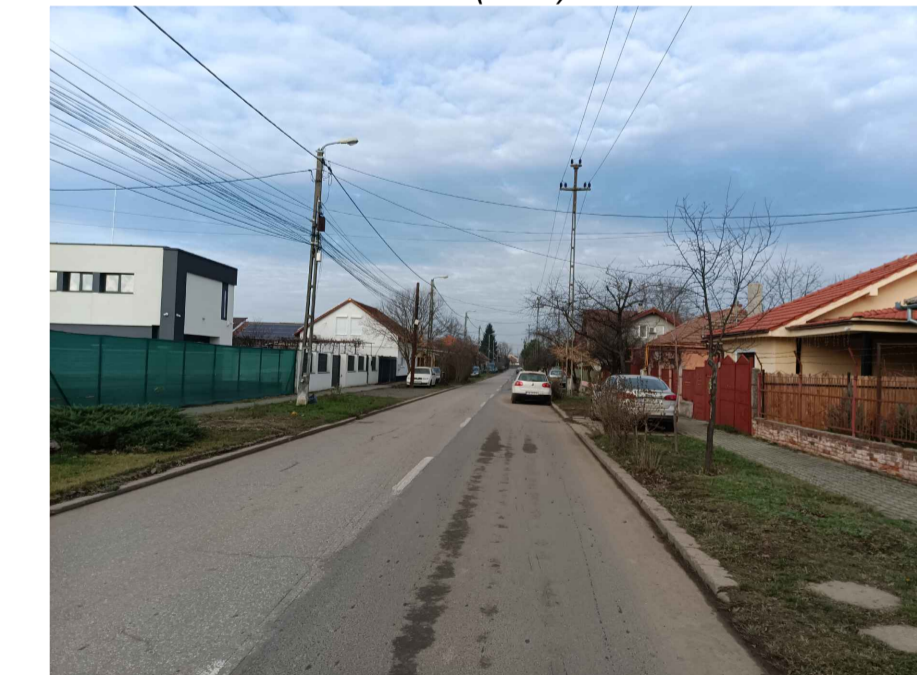
strada Constantin Daniel (15m)

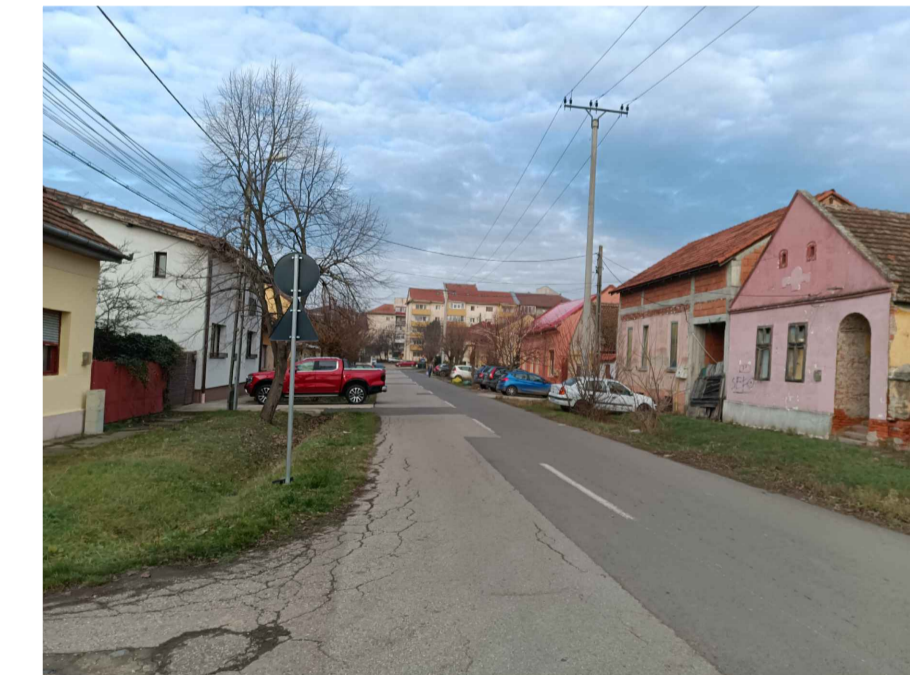
strada Nicolae Filimon (18m)

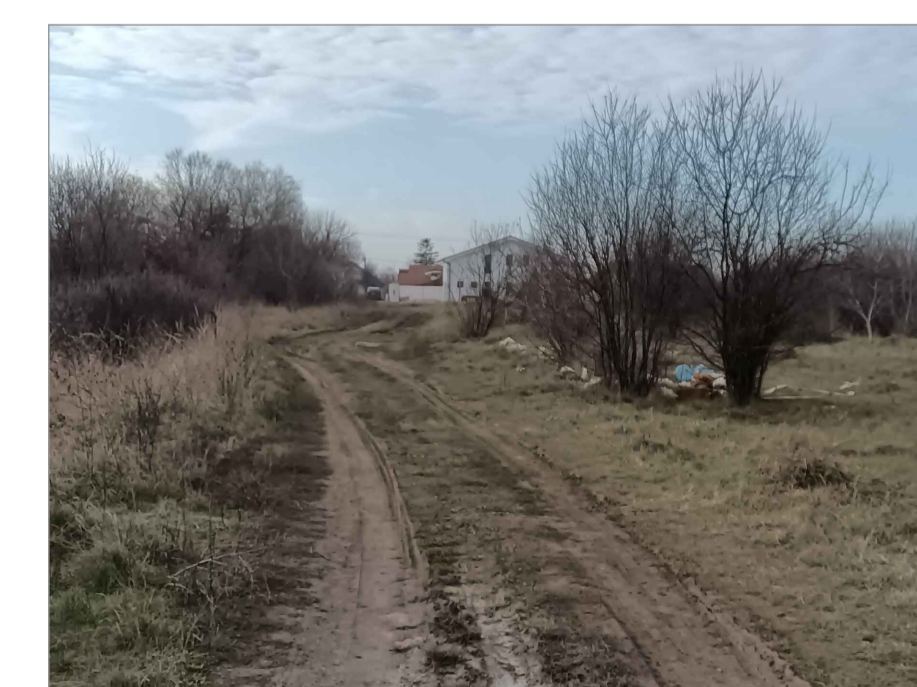
strada Bela Lugosi

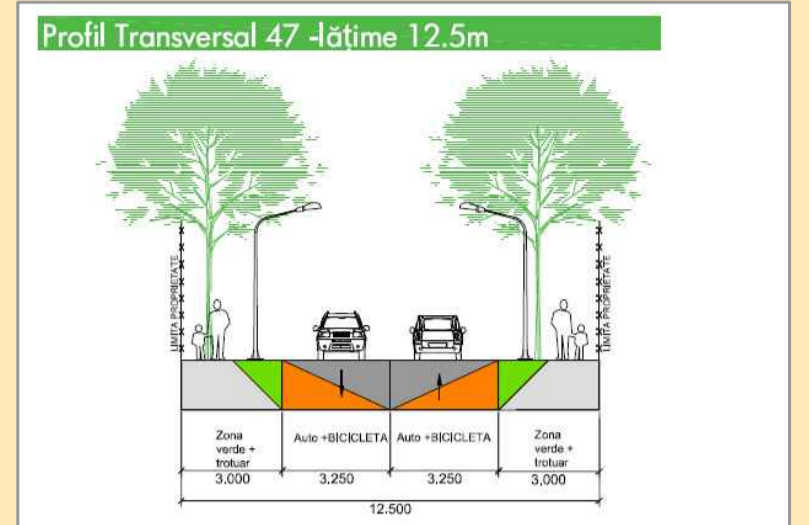
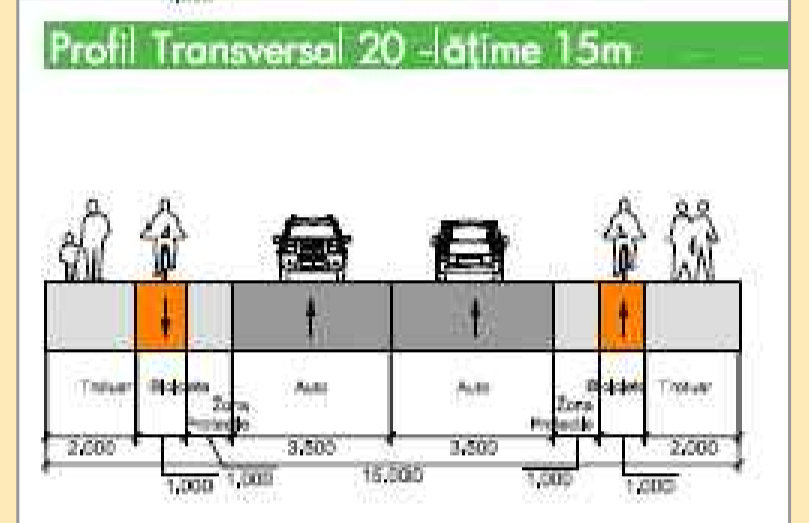
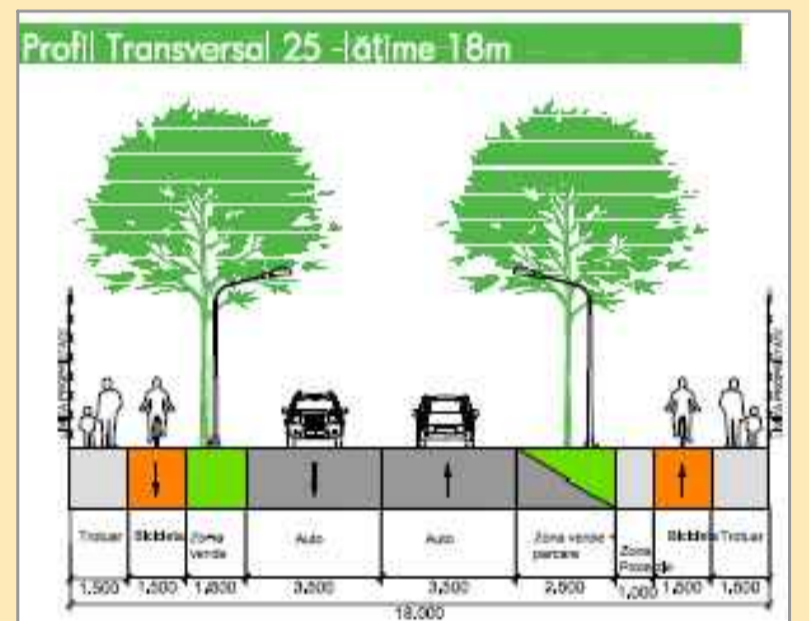
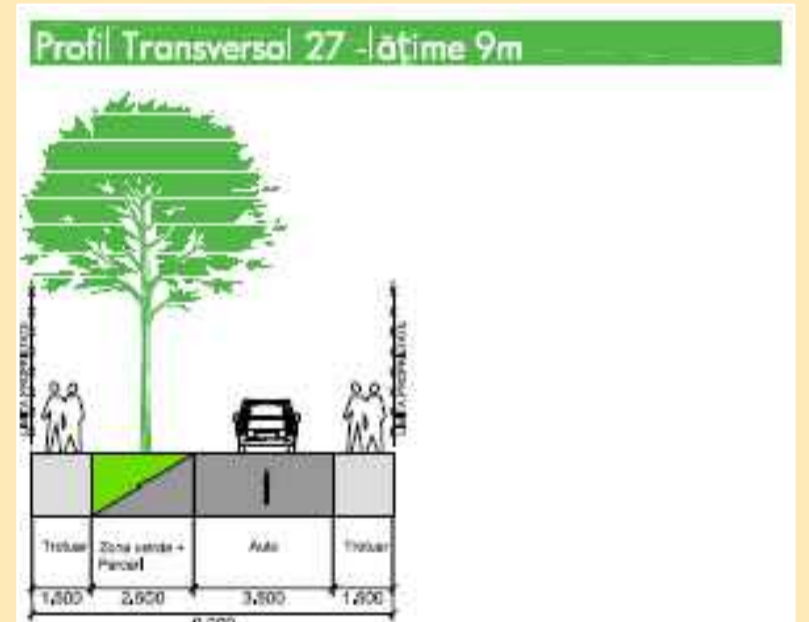
Extras PUG - Anexa 6, Organizarea profilului stradale
